Mt. Washington Alpine Resort Water System Annual Report 2021

2. Mt. Washington Alpine Resort Water System

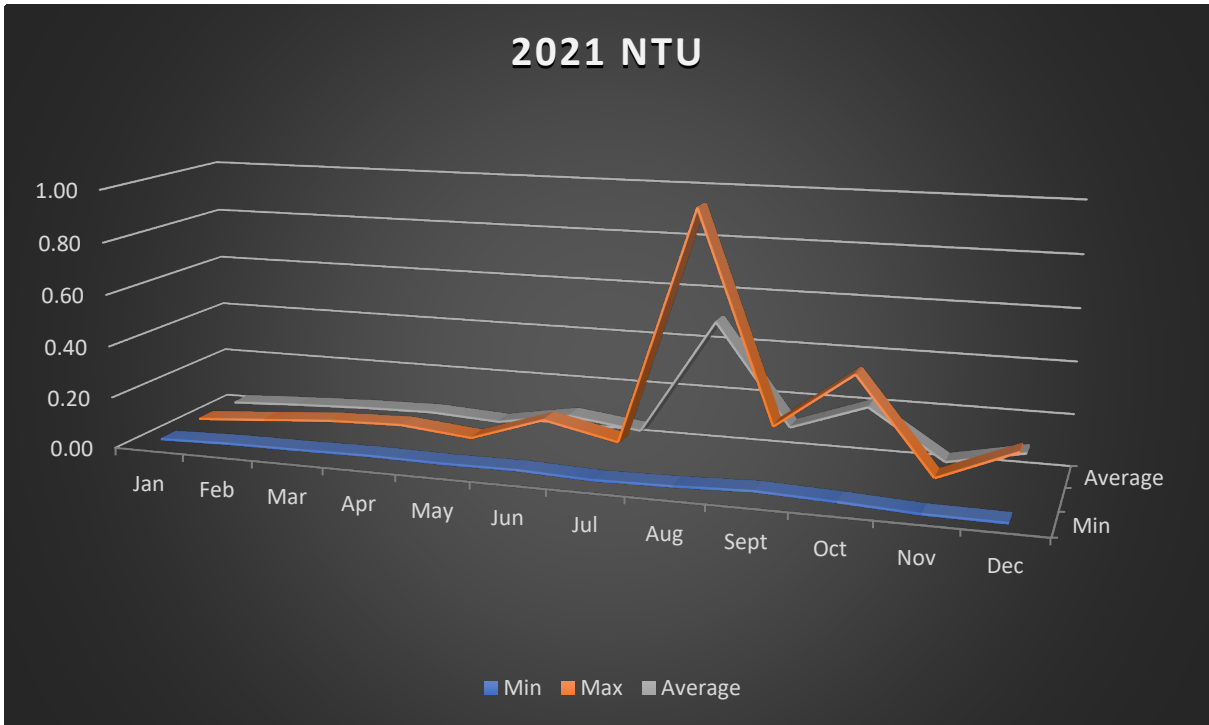
Due to the remote nature of the environment and the quality of the water from our springs, we have consistently low turbidity levels. Occasional high readings are observed, which typically coincide with heavy rain events, storms or rapid spring melts. As shown in the graph above, average values are generally well below 1.00 NTU.

Turbidity is a measurement of the cloudiness of water. Reported in nephelometric turbidity units (NTU), it is an optical measurement of water's ability to scatter and absorb light rather than transmit it in straight lines. Turbidity is caused by fine suspended particles of clay, silt, organic and inorganic matter, plankton, and other microscopic organisms that are picked up by water as it passes through a watershed. It is an important water quality indicator because contaminants such as bacteria and viruses can attach themselves to the suspended particles in turbid water. These particles can interfere with disinfection.

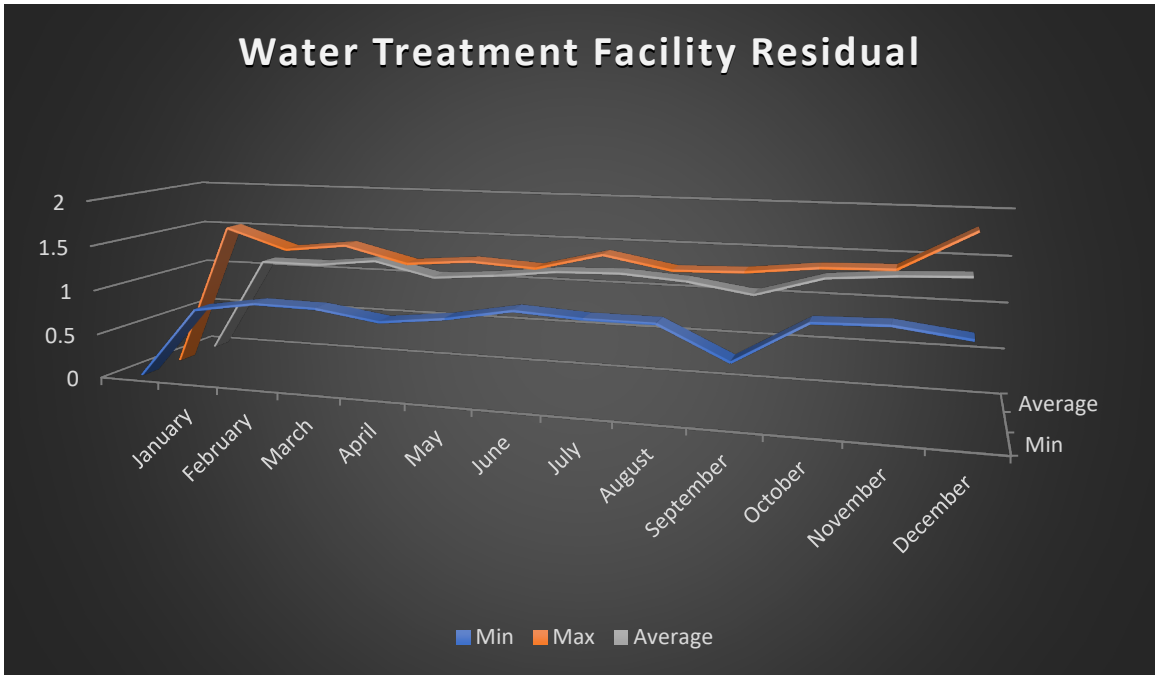
Water Treatment Facility Residual

Sodium hypochlorite is injected into the raw water as it is pumped up to the treated water storage tank. Allowing the solution to mix thoroughly in this tank provides sufficient contact time between the disinfectant and the water. Some of the chlorine is used up in the disinfection process. The residual chlorine is measured continuously by an online analyzer at the water treatment facility, the first tap on the distribution system. Our goal is to meet the 4-3-2-1 guidelines set out by Island Health. The following graph displays the maximum, minimum and average measured chlorine residuals for each month in 2021.

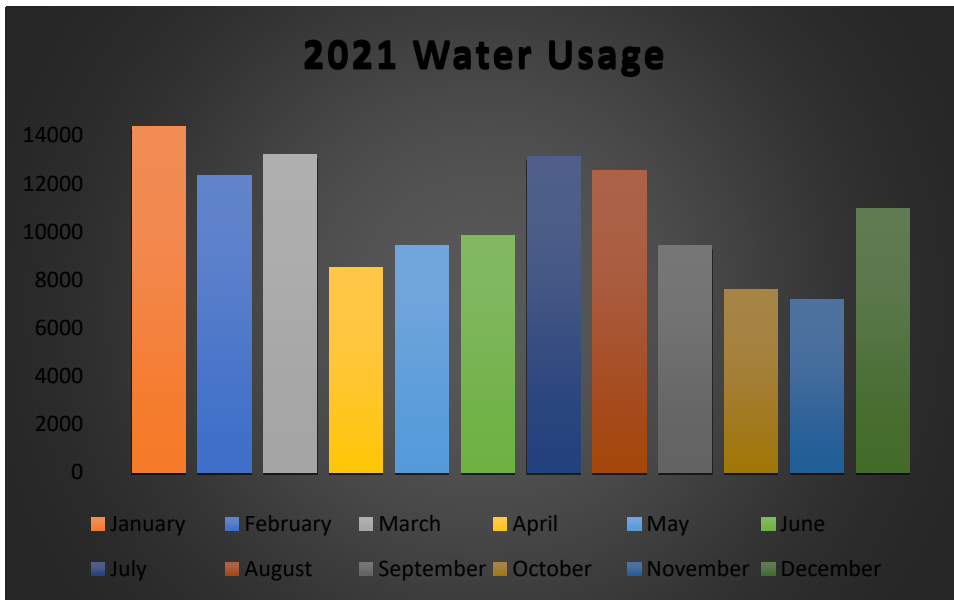
Since the covid-19 pandemic cut short the 2020 ski season, Mt. Washington has been fortunate to maintain an above average amount of skier visits and village bookings this year. Our water usage for this year reflects this but is also slightly higher as we were not mandated to have porta potties for customers which slightly increased usage from last year. A considerable structure fire last year also increased water used but thankfully in 2021 we did not have that issue. Although as seen in July/August, we had considerably higher usage than average due to a leak which coincided with an above average mountain bike season.
